# Applicability of the Visual Screening for Buildings Safety against Earthquakes ~A Case Study on Hatay, Antakya, Turkey~

建物の地震に対する安全性を確保するための目視スクリーニングの適用性検討 ~トルコ、アンタキヤのハタイ市の事例 ~

Graduate School of Societal Safety Sciences Kansai University Vladimir Enrique Guzman Javier 関西大学 社会安全研究科 ブラデイミルエンリケグスマン・ハビエル Faculty of Societal Safety Sciences Kansai University Koji ICHII 関西大学 社会安全学部 一井 康二

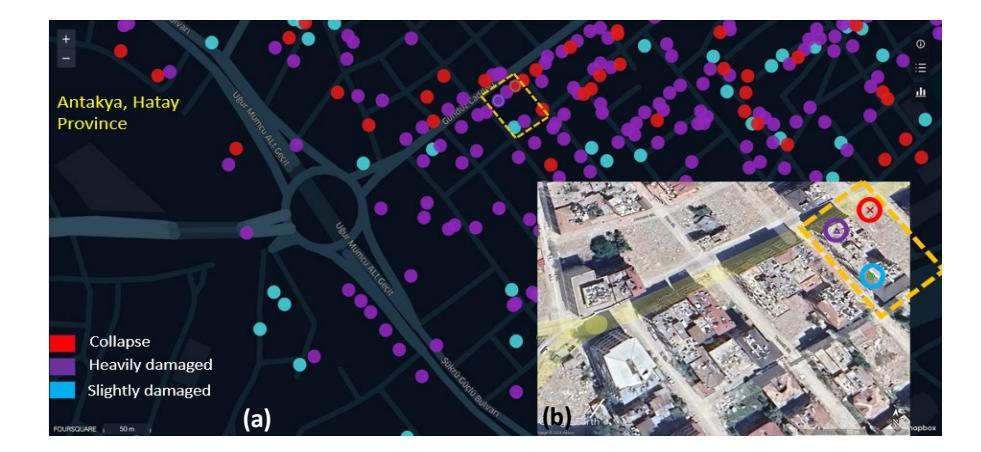
Figure 1. Example of the identified location of houses and damage levels considered in Hatay (Close-up view).

Figure 1 shows a close-up view of the identified location of houses and damage levels in Hatay. Herein, "collapsed" is defined as a building in ruins, "heavily damaged" as concrete construction destroyed, and "slightly damaged" as repairable buildings after the seismic event. See the details in the reference [15].

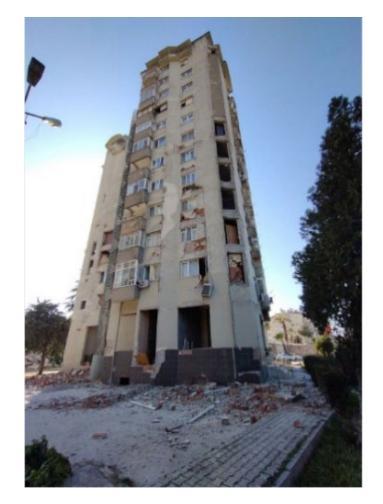
Figure 2. Example of building image from roads nearby.Source:https://www.iclr.org/wpcontent/upl oads/2023/07/EERI-LFE 20230630 ICLR.pdf

For example, the building shown in Figure 2 is a system-type C3, which corresponds to reinforced concrete buildings with unreinforced masonry infills and RC buildings with concrete shear walls.

And most of the buildings in the study area were of this type. Based on the FEMA sheet presented in Figure 3, first, the building type was identified as RC buildings, thus system type C3 was selected. The basic score for this type was 1.2. Then, a score modifier of -0.7 was assigned for the severe irregularity.

These are the procedures used to evaluate the score from Google Street View images. And as an example, the final score of 0.4 was assigned to the building shown in Figure 2.

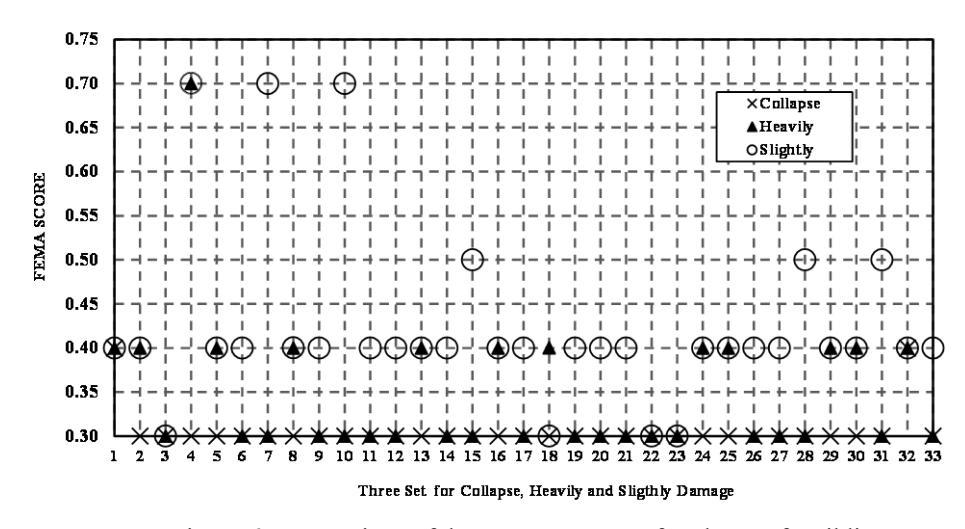
Figure 6. Comparison of the FEMA Scores of each Set of Buildings.

From Figure 6, it can be observed that most collapsed buildings have a 0.3 score. In contrast, most of the slightly damaged buildings are 0.4 or more. And the scores for heavily damaged are between these, except for set 18. In the majority, the score of heavily damaged buildings is less or equal to the score of collapsed buildings. In addition, the score of slightly damaged is less or equal to the score of heavily damaged buildings. Interestingly, FEMA scores are equal in three sets for collapse, heavily and slightly damaged, particularly in sets 1, 3, 22, 23, and 32. This is because the difference cannot be identified from the visual screening for this data. For example, it can be the difference that comes from the level of deterioration on the interior of the structures. This just means about the limitations of the visual screening.

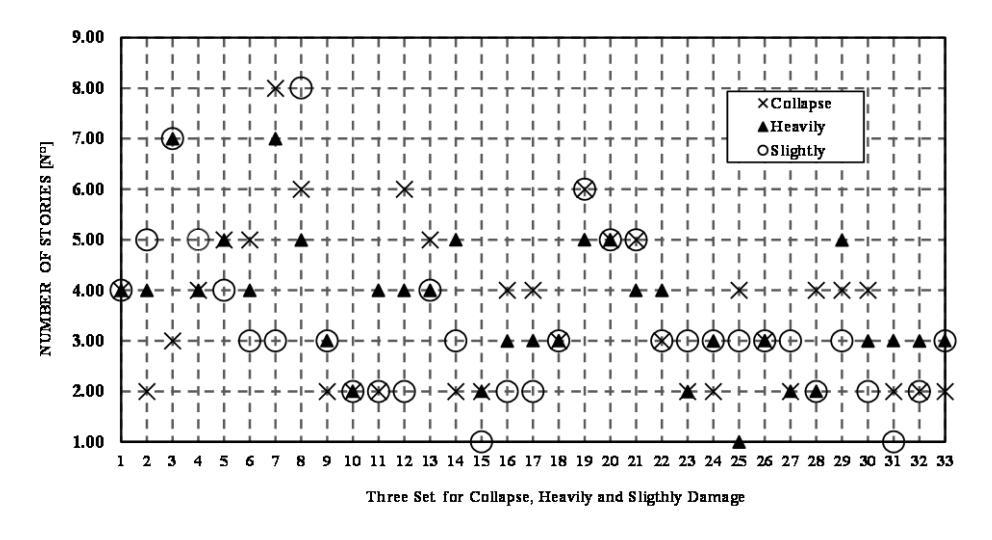
Figure 7. Comparison of the Number Stories of each Set of Buildings.

Figure 7 shows that the 2 buildings with 8 stories are the tallest. And one was collapsed, but the other was slightly damaged.

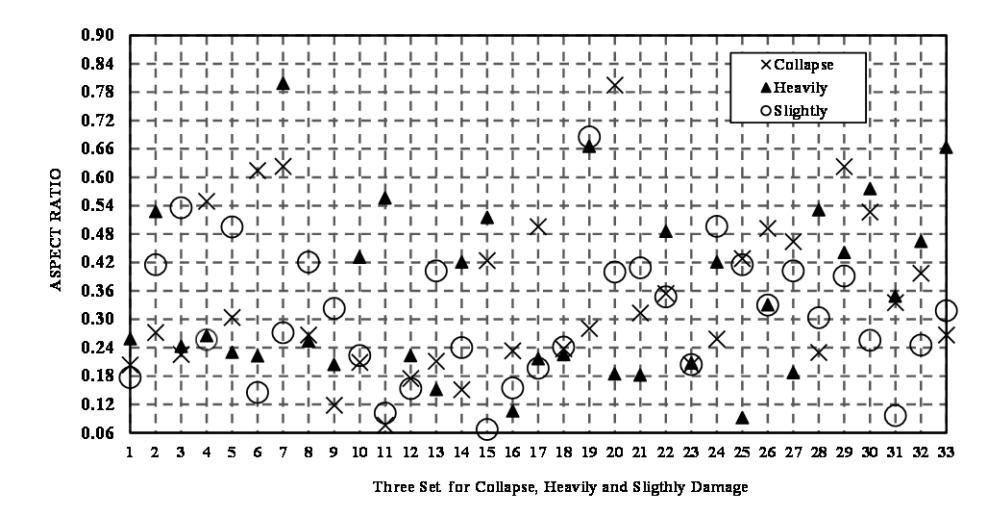
Figure 8. Comparison of the Aspect of Ratio of each Set of Buildings.

In Figure 8, the level of damage in slim buildings can be discussed. In set 20, the slimmest building was collapsed. However, in set 19, the building with the smallest aspect ratio collapsed.

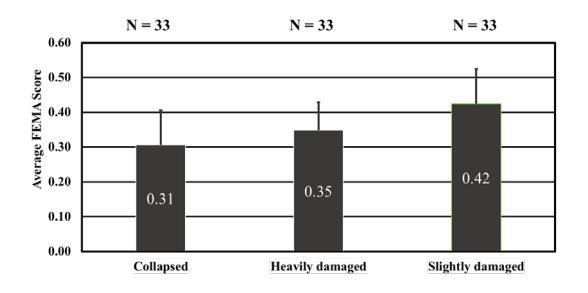
Figure 9. Average FEMA Score per level of damage.

Figure 9 shows the comparison of the average FEMA scores in building groups. The building group with less damage shows a higher FEMA score. We have applied ANOVA (Analysis Of Variance) [20], to check the significance of the trend. This trend is statistically significant since the

*p*-value is quite small ( $p = 2.80 \times 10^{-8}$ ).

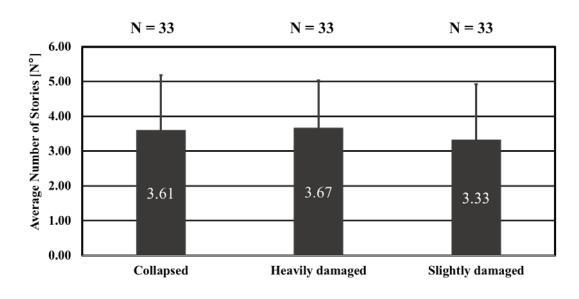
Figure 10. Average Number of stories per level of damage.

Figure 10 shows the comparison of the average in the Number of stories in building groups. The building group with less damage tends to have a smaller number of stories. However, this trend is statistically insignificant from statistical verification with ANOVA (p = 0.63715). Figure 11 shows the comparison of the average aspect of ratio in building groups. The building group with less damage tends to have a smaller aspect ratio. However, this trend is statistically insignificant from statistical verification with ANOVA (p = 0.48511).
