# Applicability of the Visual Screening for Buildings Safety against Earthquakes ~A Case Study on Hatay, Antakya, Turkey~

建物の地震に対する安全性を確保するための目視スクリーニングの適用性検討 ~トルコ、アンタキヤのハタイ市の事例 ~

Graduate School of Societal Safety Sciences Kansai University Vladimir Enrique Guzman Javier 関西大学 社会安全研究科 ブラデイミルエンリケグスマン・ハビエル Faculty of Societal Safety Sciences Kansai University Koji ICHII 関西大学 社会安全学部 一井 康二

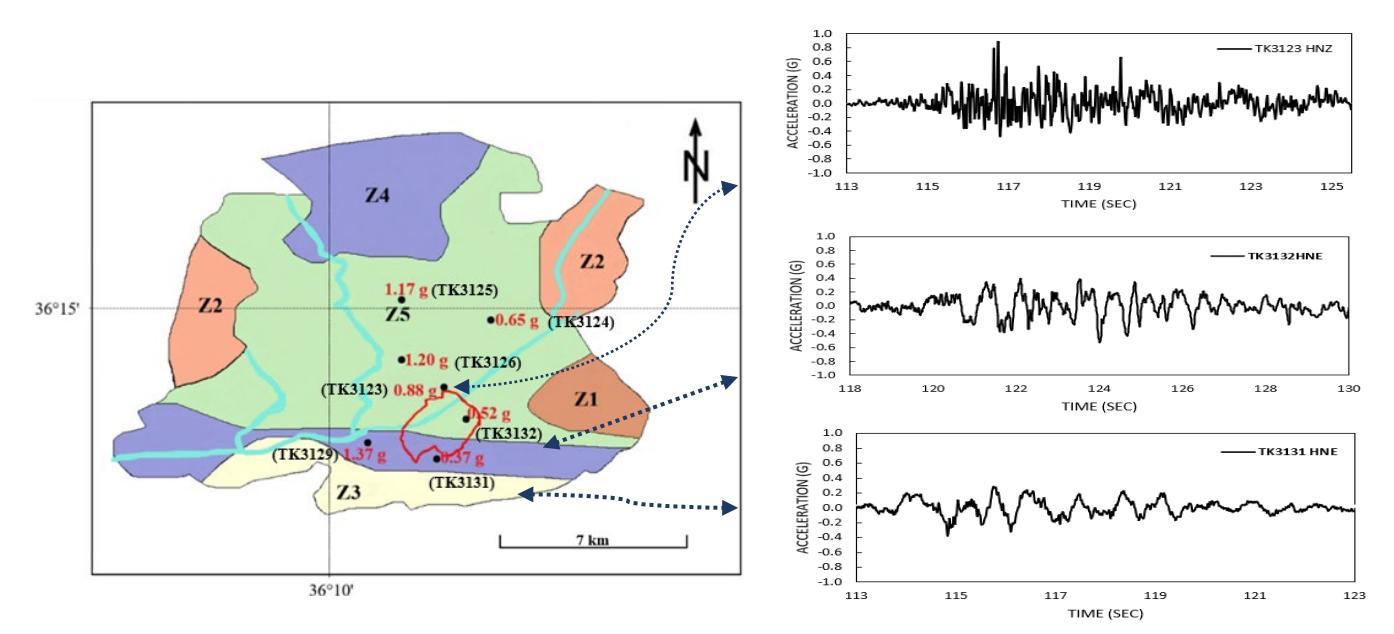
Figure 4. The study area (red polygon), microzonation of Hatay [17], and strong motion observation sites nearby (black dot) [18],[19],. Source: Adapted from Google Earth

this area was located in Zone 4 and Zone 5.

There were seven (7) strong motion observation sites near the area, as shown in Figure 4. The observed shaking level of the M7.7 earthquake (PGA: Peak Ground Acceleration) of the area was about 0.37 g to 0.88 g, although stronger shakings beyond 1 g were observed outside of the area. And, the difference of shakings within the study area was not significant. As shown in Figure 4, the seismic waveforms observed around the study area were not so different except for the high-frequency component observed in TK3123, where a spiky peak provided a larger PGA. Note that, although the difference in high-frequency shakings remained, our methodology of picking up all three different damage levels of buildings nearby can minimize the effects of these shaking differences in the study area.

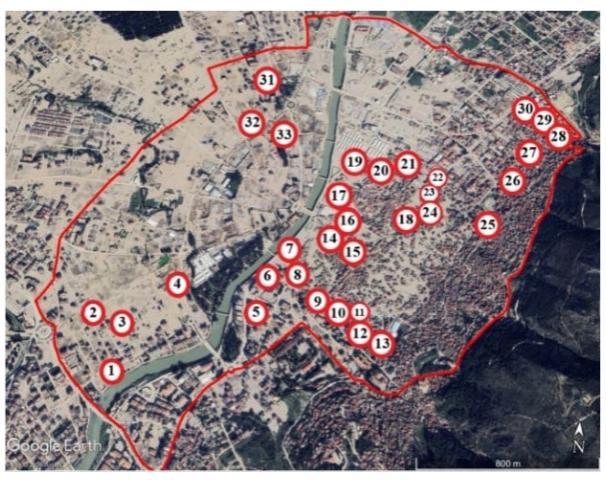
Figure 5. Summary of picked-up buildings in the study area., 99 damaged buildings with three levels of seismic damage (33 sets) on satellite images.

Figure 5 shows the summary of picked-up buildings. There are 99 damaged buildings with three levels of seismic damage (33 sets).

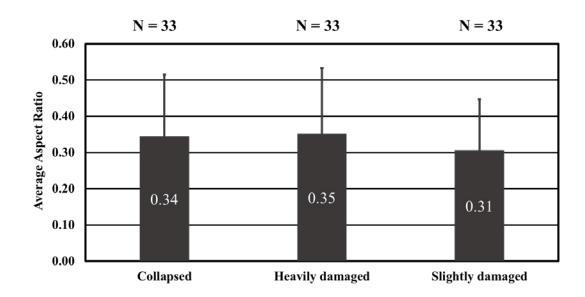
Figure 11. Average Aspect ratio per level of damage.

Figure 10 shows the comparison of the average in the Number of stories in building groups. The building group with less damage tends to have a smaller number of stories. However, this trend is statistically insignificant from statistical verification with ANOVA (p = 0.63715). Figure 11 shows the comparison of the average aspect of ratio in building groups. The building group with less damage tends to have a smaller aspect ratio. However, this trend is statistically insignificant from statistical verification with ANOVA (p = 0.48511).
